## **WHAT DID THE NINTH FORT OF KAUNAS FORTRESS LOOK LIKE IN 1915-1916?**

*Martynas Kosas*

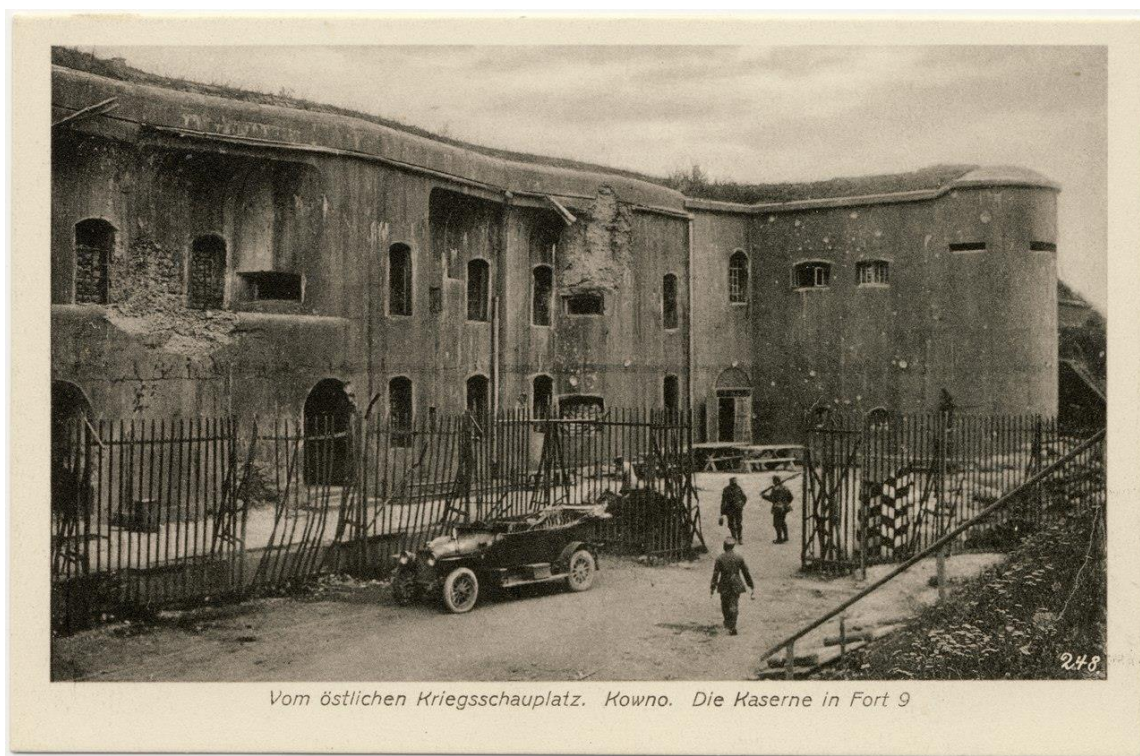
Barracks of the Ninth Fort of Kaunas Fortress, 1915 © KDFM (GEK-33546)

photographed and documented the surroundings of the Ninth Fort, the internal equipment and the views of the area. However, only one photograph of the Ninth Fort of Kaunas Fortress has survived, in which an unknown war photographer captured a view of the fort in late August or September, 1915. As the photograph is numbered 248, this suggests that there were many more photographs of the fort. The caption in German on this photo 248 reads the following: "Vom östlichen Kriegsschauplatz. Kowno. Die Kaserne in Fort 9" (English: "From the Eastern Warfare Site. Kaunas. Casemate of the Ninth Fort"). Looking at the photo, one can see a view of the fort taken shortly after the retreat of the garrison led by Captain F. Demidenko. The two-storey concrete barracks and the semi-caponier are visible. The windows of the barracks are covered with sandbags used by the fort defenders to prepare for defense. On the facade, one can see two places where German artillery shells hit the fort, one of which can be seen now as well. The approaches to the fort were enclosed by a few metres high defensive barrier, which was damaged during the shelling. In the courtyard, four soldiers of the German Empire can be seen, one of whom is a guard standing at the gate with a rifle on his shoulder, the other two soldiers are walking with food cauldrons, and the fourth one, wearing a light-coloured jacket, is probably an officer. A fort guard's hut, painted black and white, is built at the gate, and a little further on, at the entrance to the semi-caponier, tables and benches from the fort's premises are stacked up. A car of an unidentified model is parked near the fort gate. The analysis of such photographs can provide us with many historical details, i.e. what the site looked like at the time. However, of course, a single photograph is not enough to reveal all the details, especially if it is a larger object.

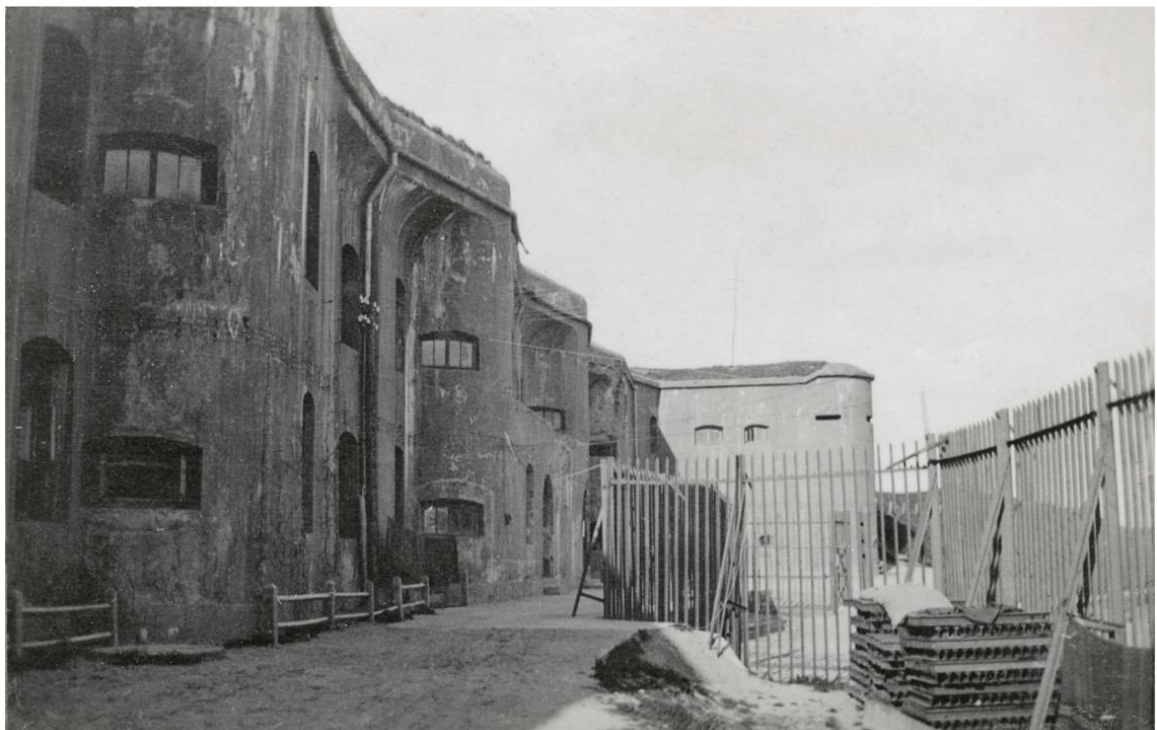
The second photo shows the fort's courtyard from the south-west to the north-east. On the left, one can see the facade of the fort's barracks. A communication or power line is mounted on the facade. There are cannon holes with glazed sash windows. An electricity or communication pole with ceramic insulators is attached to the facade. A low wooden fence can be seen immediately adjacent to the fort wall. Two blankets are hung on an outstretched rope near the facade. The inner courtyard is not yet fully formed, only the ground has just been trampled down, while on the right there are the protective bars that surrounded the fort. Their fixing from the inside is visible. Next to the bars, the cut railway rails are stacked in piles, which had to be used to cover the windows of the barracks during the assault. A pillow and a blanket are placed on top of the stacked rails, and a grey soldier's blanket with a coloured stripe is hanging on a rope nearby. In the foreground, as in the preceding photograph, there is the fort's semi-caponier with an antenna or flagpole on the roof.

Courtyard of the barracks of the Ninth Fort of Kaunas Fortress with a semi-caponier in the background, 1915-1916. © Bayerisches Hauptstaatsarchiv

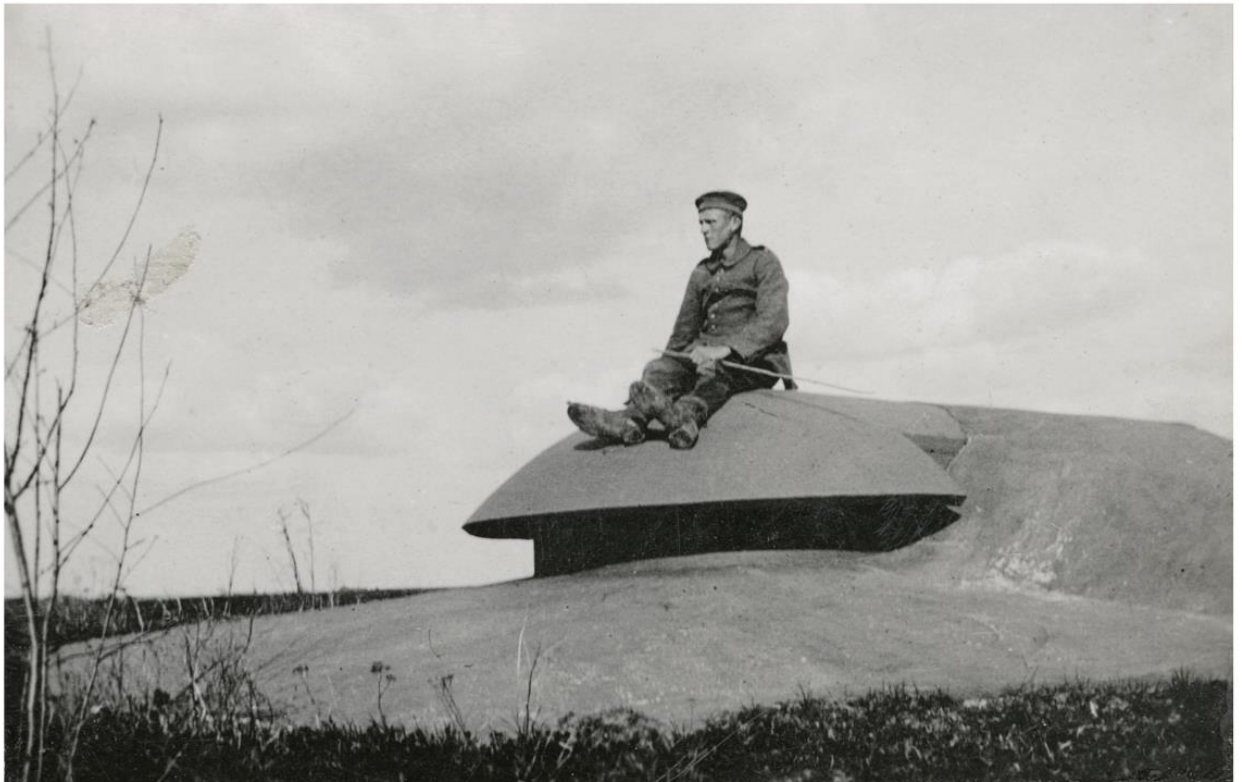
The third photo has the least detail, but it is the one where we can see the object that was rarely photographed. It is an armoured observation turret designed and built by the Tsarist Russian military engineer A. Ariens. The photograph shows the concrete top of the turret, a steel dome with observation holes, rising above the roof. Interestingly, the steel dome is probably painted grey. A German imperial soldier is sitting contemplatively on top of the turret, holding a stick in his hand. The soldier is wearing a 1914 'M14 Waffenrock' transitional jacket and the boots of 1866 model. On the soldier's head, there is a 1910 'Feldmütze M10' military cap with a grey camouflage stripe.

A German imperial soldier is sitting on the A. Ariens system armoured observation turret on the roof of the barracks of the Ninth Fort of Kaunas Fortress, 1915-1916. © Bayerisches Hauptstaatsarchiv
